## LINED IRRIGATION CANALS IN FIELD HUNTING GROUNDS OF VOJVODINA AND THEIR INFLUENCE ON WILDLIFE

**ABSTRACT:** Irrigation canals lined with smooth materials (e.g. geomembrane, concrete) are potential barriers which disturb and restrict wildlife movement in numerous field hunting grounds in Vojvodina. The adverse effect of lined irrigation canals can be additionally increased due to drowning of both wild and domestic animals, or because of a permanent fence erected along some lined irrigation canals. This paper presents the results of multiannual monitoring of wildlife behaviour related to the lined irrigation canal “Kula-Mali Idoš” (Bačka region), with special emphasis on wildlife overpasses and their efficacy in connecting the parts of the fragmented habitat. The study results show that the overpasses are used by different wildlife species, the most frequent of which are brown hare (*Lepus europaeus*), roe deer (*Capreolus capreolus*) and fox (*Vulpes vulpes*).

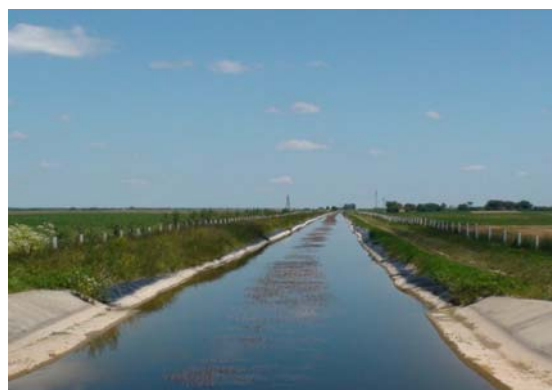
**Figure 1:** Lined irrigation canal “Kula-Mali Idoš” (start)

The study area is the canal “Kula-Mali Idoš” located along the border between the municipalities Kula and Vrbas (Bačka region). The canal is 5 km long, about 10 m wide and 2.5 m deep. The pumping station is in the suburb of Kula, on the bank of Veliki Bački Kanal, from

The canal was constructed and lined with plastic (polyvinyl chloride) during 2008, during the first phase of the subsystem “Mali Idoš” and the regional hydrosystem “Severna Bačka”. Several months later, a permanent fence, between 1.2 and 1.5 m high, was erected along the canal (Fig. 1). Its aim was to prevent wildlife and domestic animals from falling and drowning, and to direct their movement to overpasses.

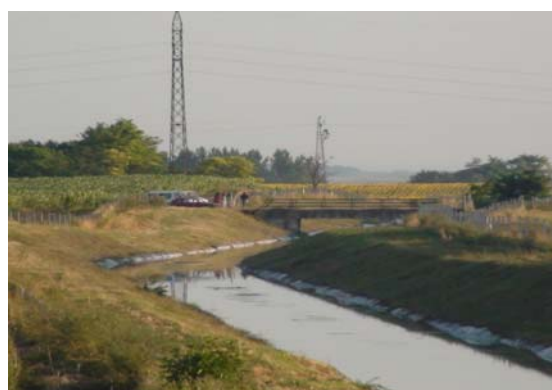
**Figure 2:** The first bridge (B1) at the 1+700 km

There are three bridges built over the canal during different periods. Two bridges (B1 and B3) were built in 2008, and the third one (B2) in the spring 2010. They are similar in sizes, length about 25 m, width of the central part 8 m, and width of the approach span about 15 m. The composition of natural vegetation on the bridges was determined based on the samples collected in September 2009 and June 2013.

Bridge B1 is located at the 1+700 km (Fig. 1), B2 at the 2+500 km (Fig. 2), and B3 at the 3+350 km (Fig. 3). Initially, the main function of the bridges B1 and B3 was to enable the people, vehicles and agricultural machines to cross the canal. During the following year, the upper surface of the concrete lining was covered with soil (10 cm deep), which was soon naturally grassed. Additionally, after two years, a new bridge (B2) was built in the middle part of the canal in the aim of better connection of fragmented habitats and for wildlife crossing and migration. For this reason, there were no concrete paths for pedestrians, and the bridge approach span was in the shape of a funnel.

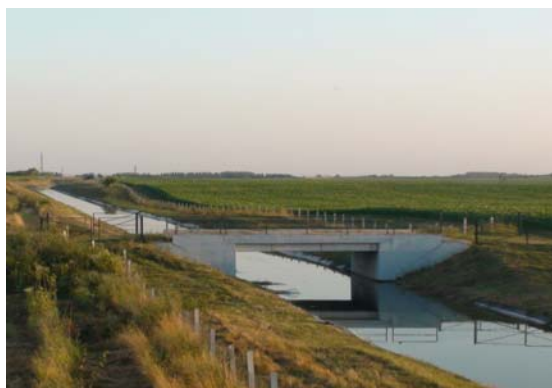
**Figure 3:** The second bridge (B2) at the 2+500 km

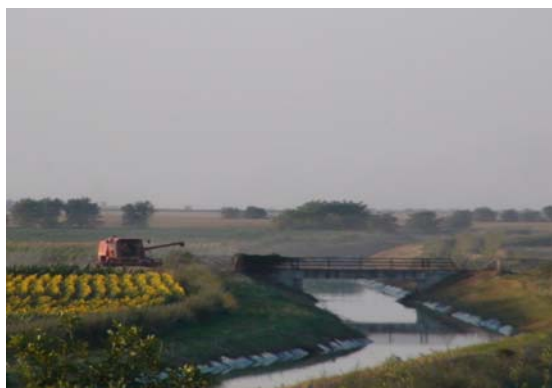
**Figure 4:** The third bridge (B3) at the 3+350 km
